North Coast Regional Water Quality Control Board

**Dairy Water Quality Inspection Report**

**Dairy Name:** Mazzetta Dairy  
**Physical Address:** 1798 Pepper Road, Petaluma, CA 94952  
**Waste Discharger ID** 1B11119DSON  
**Inspection Date:** April 14, 2014 at 2:00 P.M.  
**Inspection Attendance:** Cherie Blatt, Regional Water Board  
Ken Mazzetta, Dairy Operator  
Melissa Lema, Western United Dairymen  
Glenn Sakamoto, Environmental Protection Agency (USEPA)  
Becky Mitschele, USEPA  
**Dairy Type:** Organic  
**Cow Breed:** Holstein, Jersey cross, Ayrshire cross  
**Cow Numbers:** 310 Milking and Dry (November 2013)  
350 Other (November 2013)  
**Permitted Maximum Milking + Dry:** 350  
**Permitted Maximum Other Dairy Cattle:** 275  
**Acres Owned:** 485 acres  
**Acres that receive manure and/or process water:** 240 acres  
**Nutrient Management Plan:** 2014  
**Watersheds:** Stemple Creek

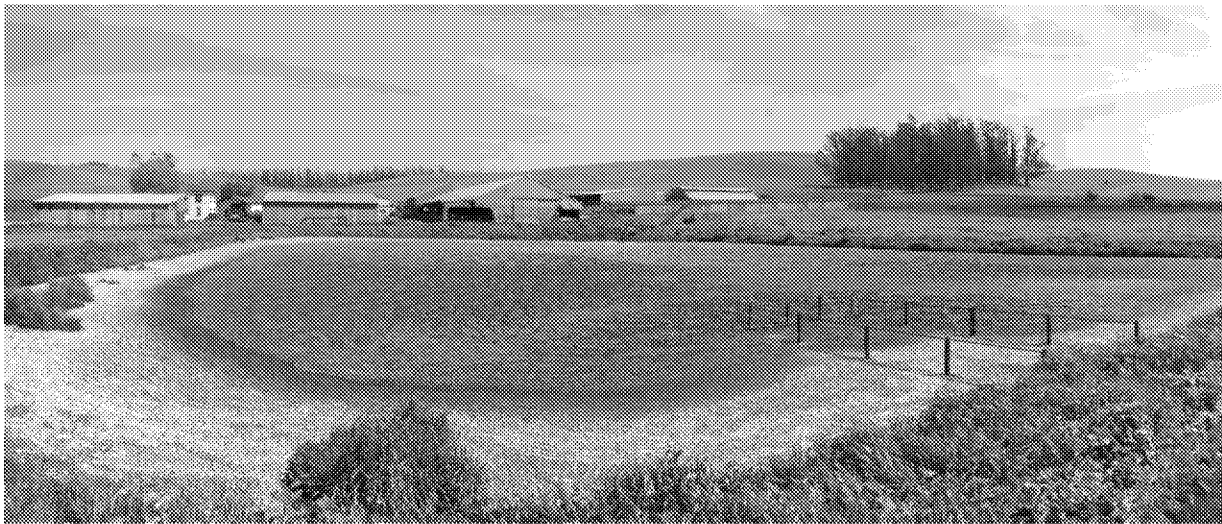
6. Liquid/Solid Pond 1

1. The West manure pond (Pond 1: liquids + solids) is located just 100 feet from Stemple Creek at its closest point. The Water Quality Plan states that the ponds are protected from 20-year peak storms. Still, the inspection revealed that weed growth on the berm of this pond was high and hindered inspection. Weeds growing on manure pond berms must be trimmed regularly to aid in checking the pond for leaks.

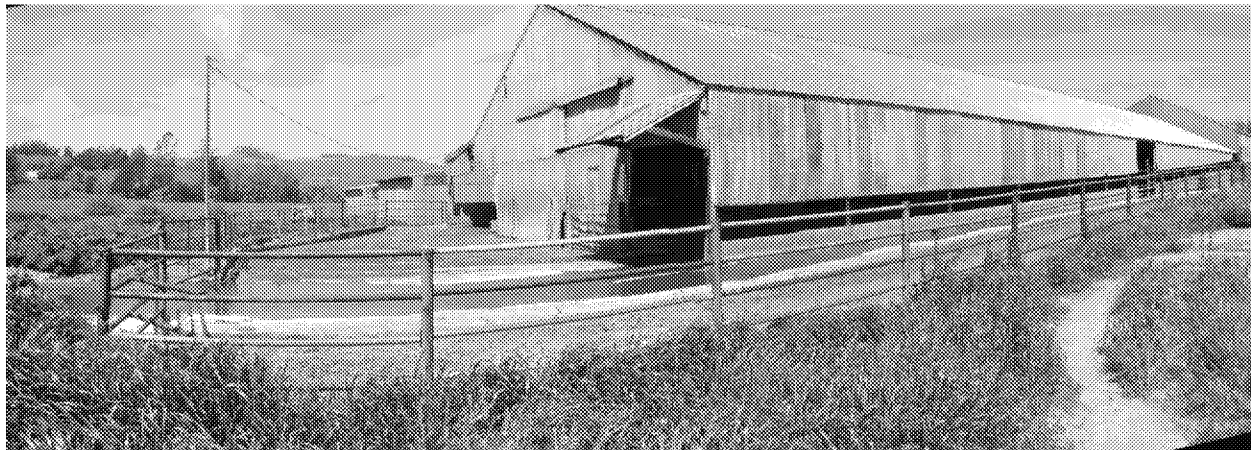
8. Concrete lane and barn scraped to manure Pond 1 (note lack of roof gutters).

2. The Water Quality Plan states that clean stormwater runoff is managed by gutters, berms, and diversion ditches. The gutters on the buildings were photographed and inspected by Regional Water Board staff during the inspection. About half of the buildings have effective gutters. However, other buildings either did not have gutters or the gutters did not effectively route clean stormwater away from the production area. Please consider repair and installation of rain gutters on buildings to route clean stormwater away from the production area. This helps to retain capacity in the manure ponds, and prevents manure-laden runoff to surface waters and groundwater.

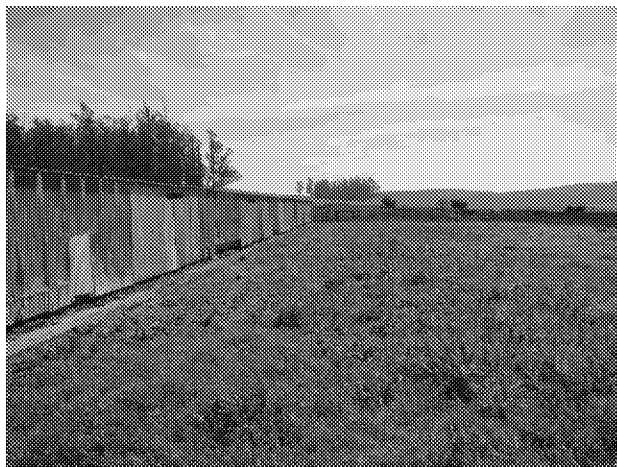
9. Southeast corner of production area. Roof drains to grassy pasture.

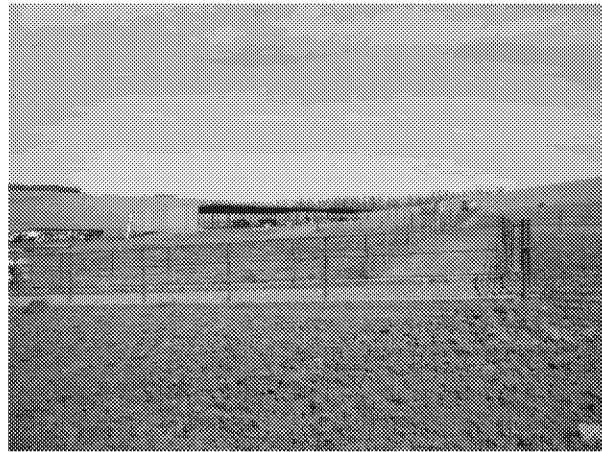
14. Southern Production Area. Note rain gutter on building on left.

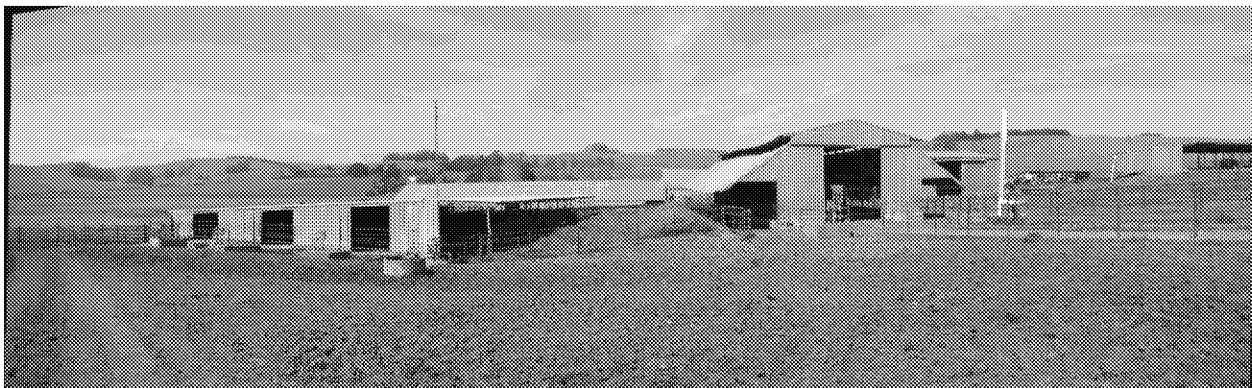
15. Southern Production Area. Note lack of rain gutters on center and left buildings.

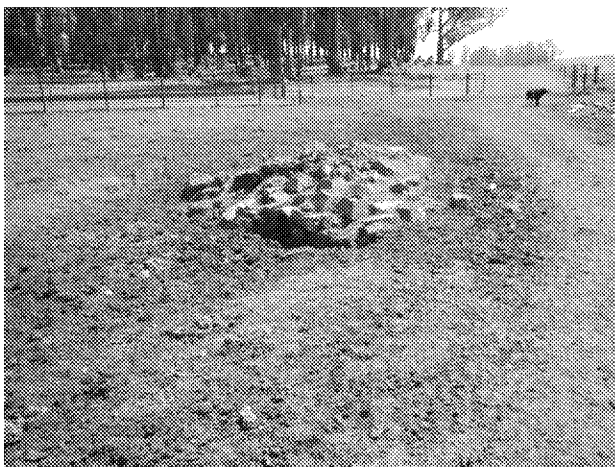
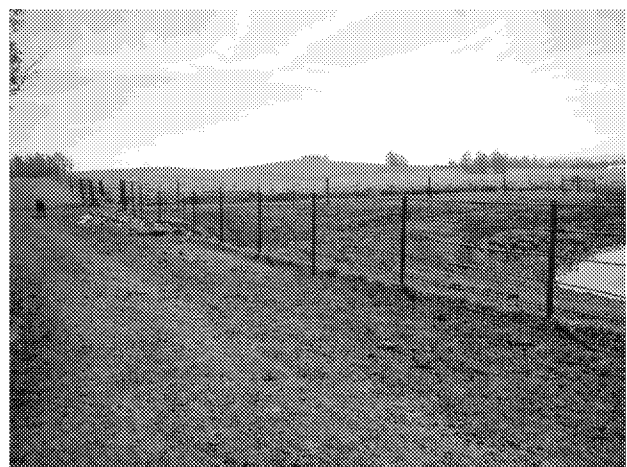
16. Corral (left) drains to Liquids Pond 2 (right) via culvert.

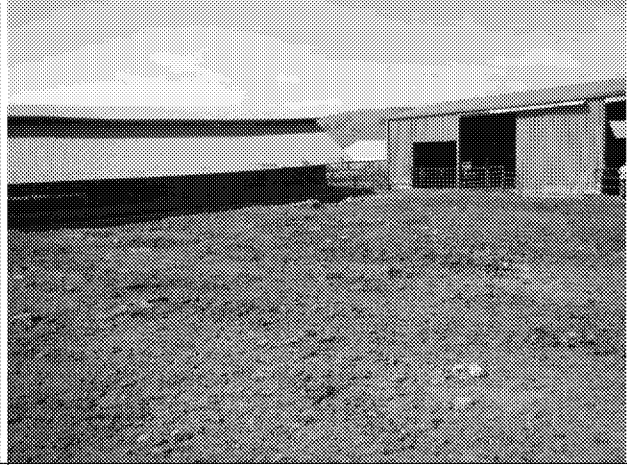
18. Central Production Area. Note broken downspout on right building

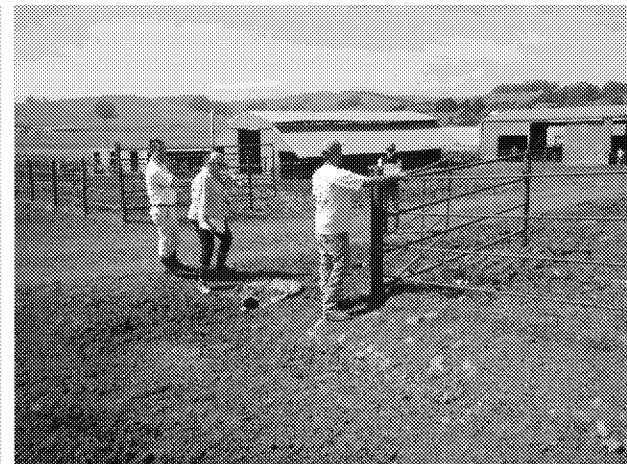
20. Southern Production Area. Note culvert drains corral to manure pond.
